## Drag chain test of a cable

| Item number: | 29001302 |
| Type designation: | Ethernet/Cat5 Li9Y91Y(St)C91Y 4xAWG24/19 |

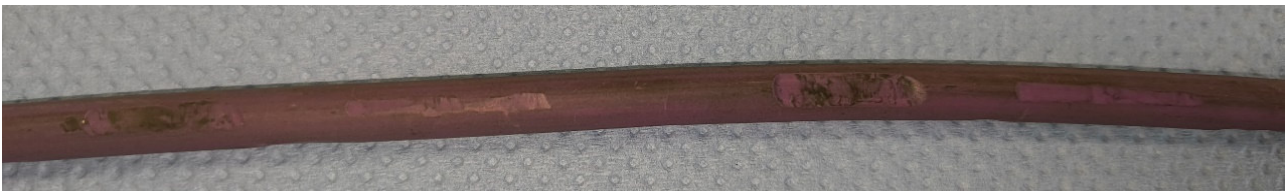
# Images of the test specimen after removal:

| <b>Note:</b> | HF measurements with Fluke at regular intervals.<br>Reason for removal: IL and RL measurements outside limit curve at 19.47 million cycles. |

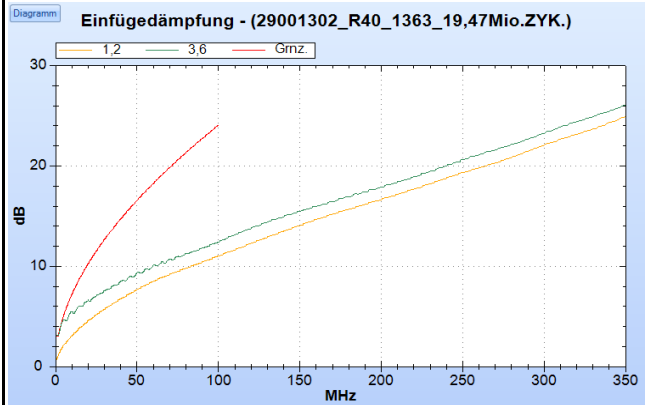
Insertion loss after removal

| <b>Note:</b> | <p>Before installation, all values were within the normative specifications.</p> <p>After removal, insertion loss (IL) and return loss (RL) were outside the limit curve.</p> |

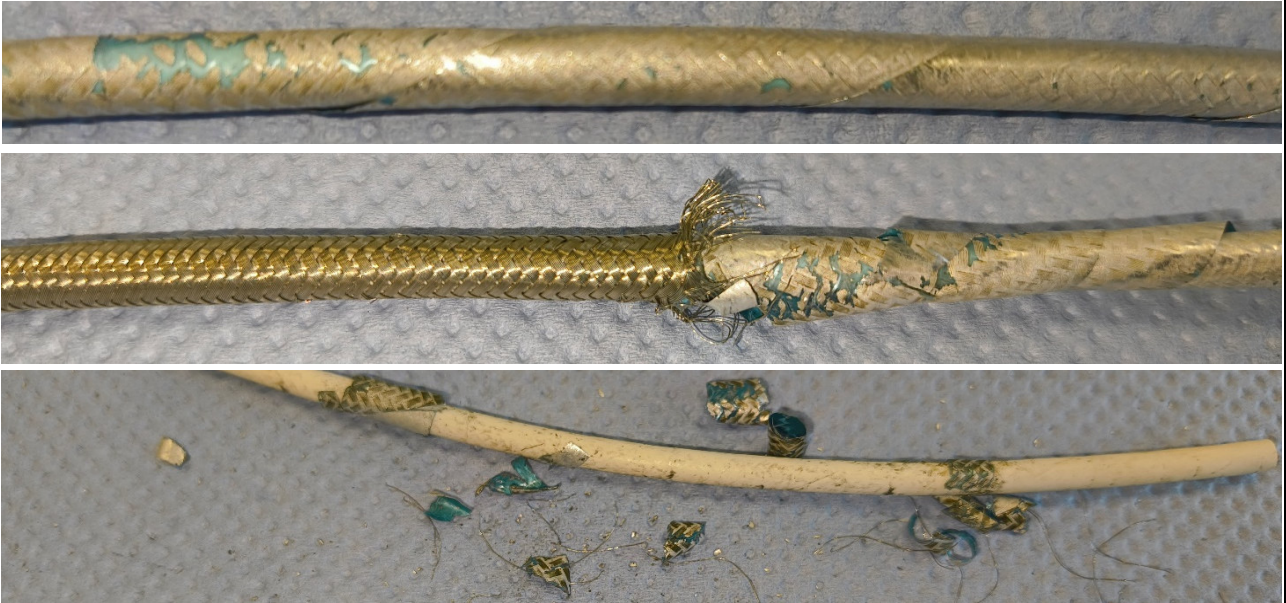
| Aluminium foil shielded | |

| Aluminium foil shielded | |
|---|---|
| <b>Note:</b> | Foil deteriorates very easily; when the shield is removed by hand, only individual pieces of the foil are revealed |

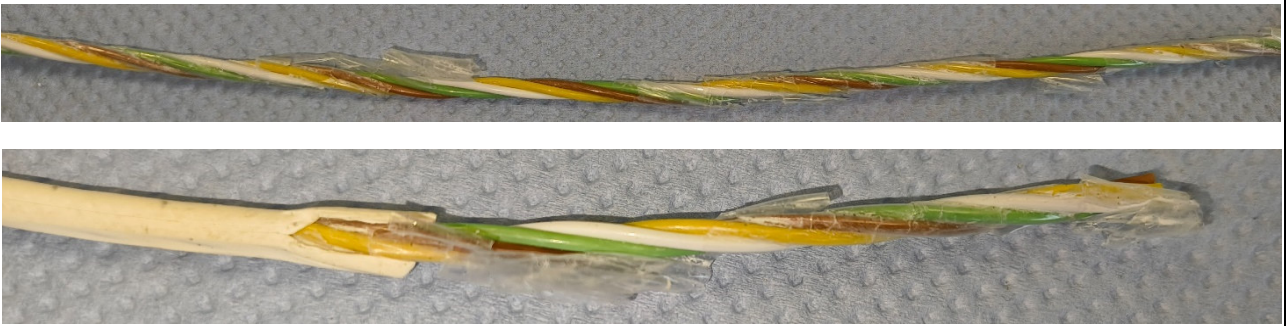
| Foil | |

| Foil | |
|---|---|
| Note: | Foil broken; only individual pieces remain beneath the inner jacket |

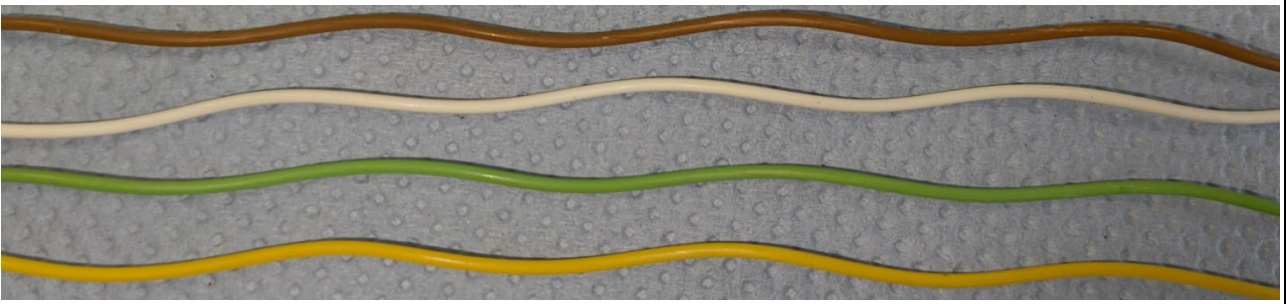
| Cores 4xAWG24 | |

| Cores 4xAWG24 | |
|---|---|
| Note: | No defects observed |
