## Drag chain test of a cable

| Item number: | 29001302 |
| Type designation: | Ethernet/Cat5 Li9Y91Y(St)C91Y 4xAWG24/19 |

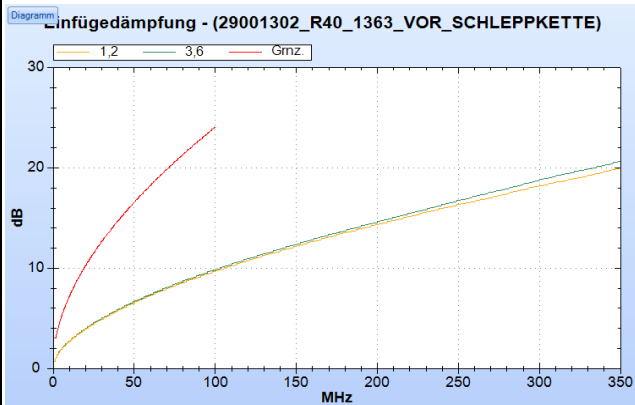
Insertion loss before installation

| <b>Note:</b> | <p>Before installation, all values were within the normative specifications.</p> <p>After removal, insertion loss (IL) and return loss (RL) were outside the limit curve.</p> |
